1000 Hour Durability Evaluation of a Prototype 2007 Diesel Engine with Aftertreatment Using B20 Biodiesel Fuel

Yolanda Bartoli
February 5, 2008
National Biodiesel Conference

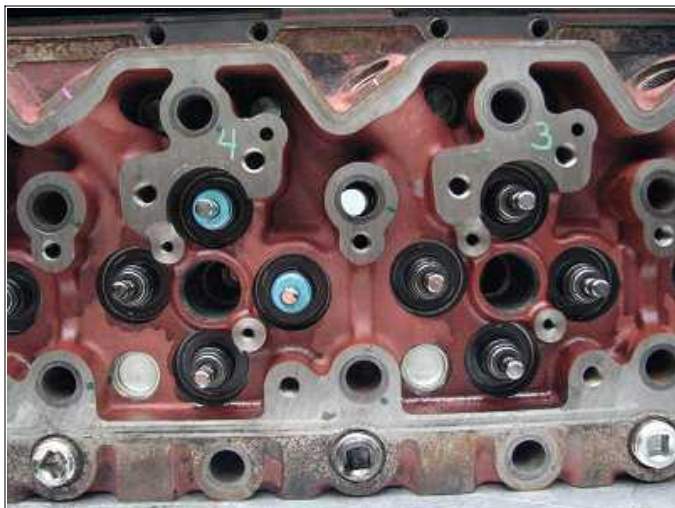
**Top of cylinder head
No sludge deposits**

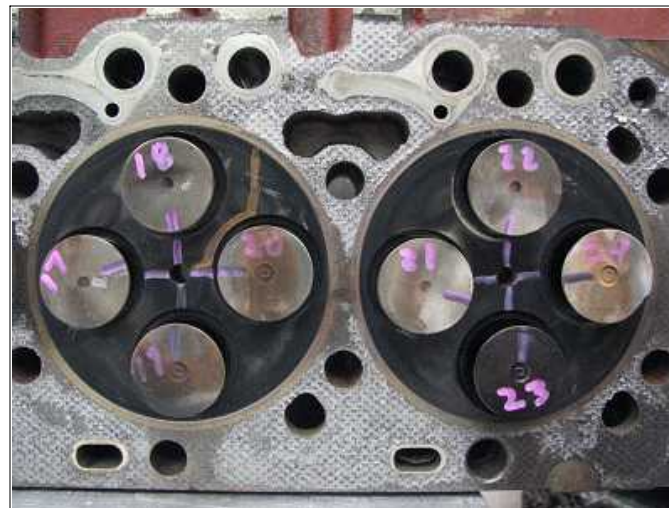
**Bottom of cylinder head
Deposits comparable to #2D**

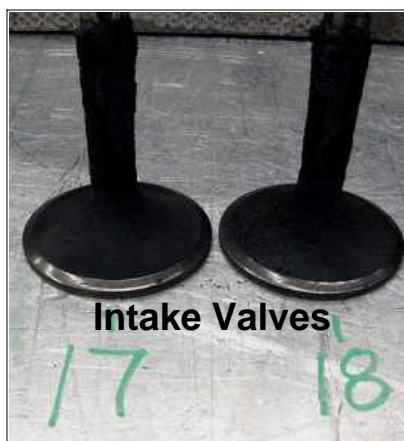
Intake Valves

**Results are typical for this type
of test with #2D diesel fuel**

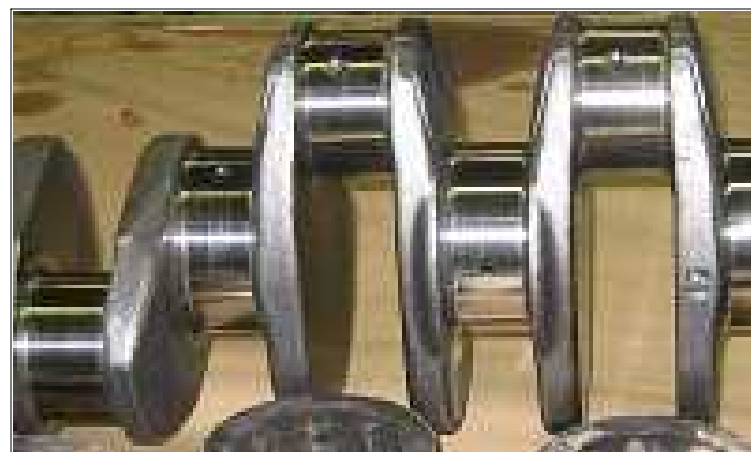
During teardown, the crankshaft was found to be in very good condition, and results were comparable to #2D diesel fuel test.

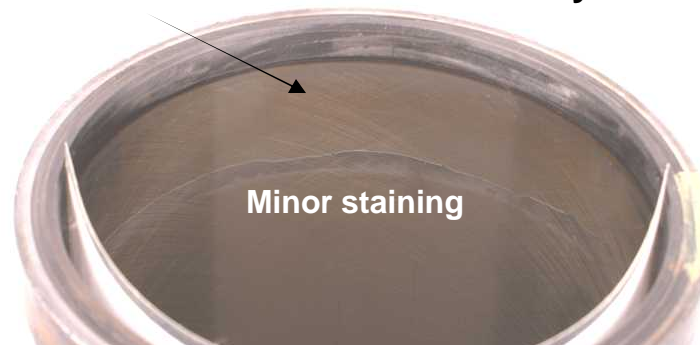
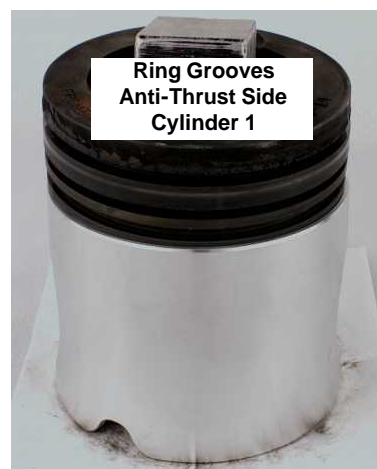
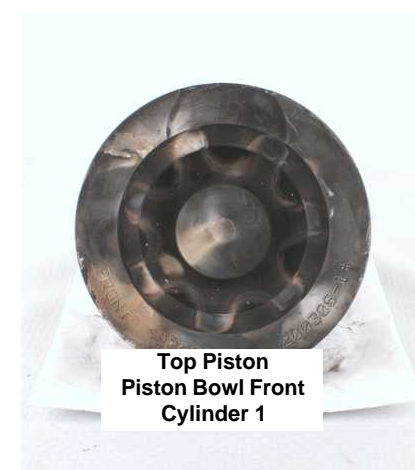
Crosshatch visible in all six cylinders.

Results comparable to #2D diesel fuel test.

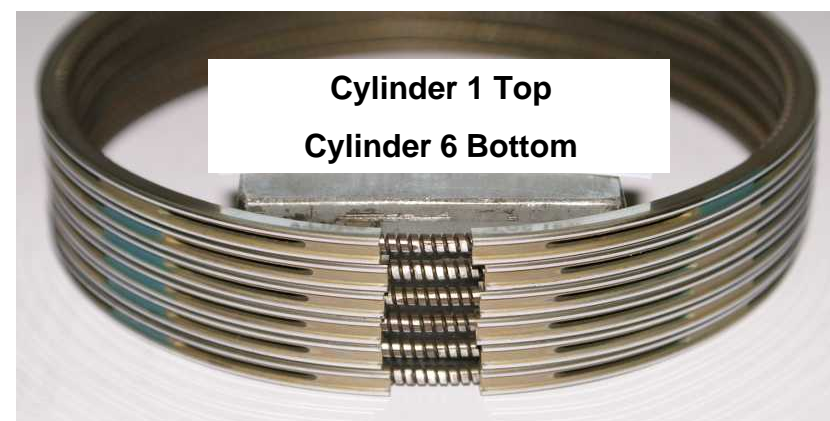
Bottom (Oil) Piston Rings

There were no failures found on the cooling and lube components. The wear and deposits found on the parts were normal and consistent with findings found on parts that ran with #2 diesel fuel in similar tests.

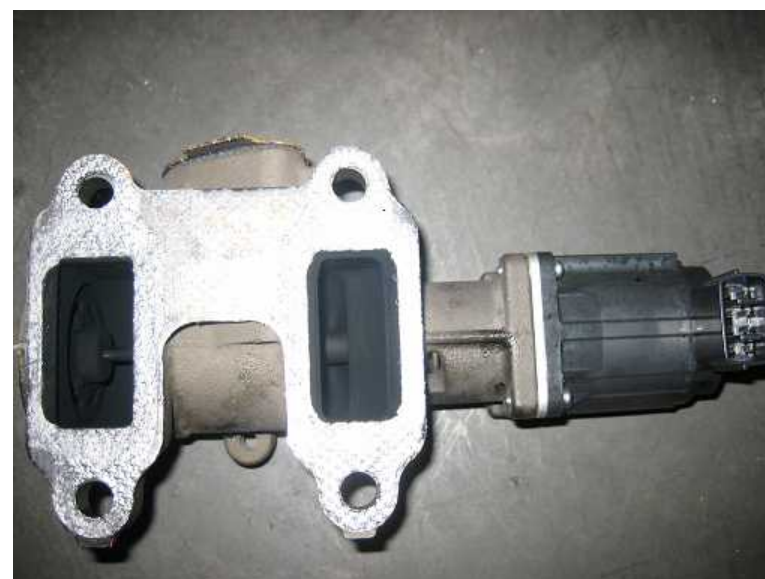
Carbon deposit layer was generated on the passage and inside parts of the **EGR valve**, but thickness was very thin and condition was dry which is normal for this durability test.

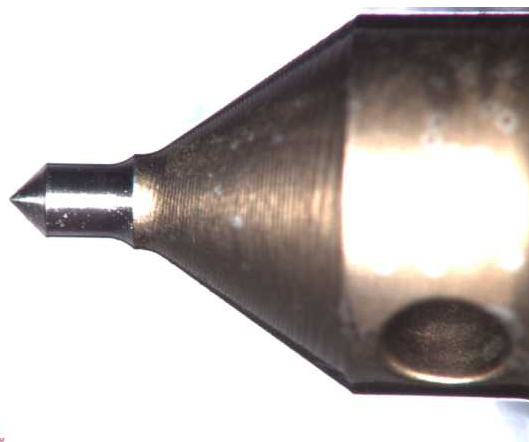
Stage 1 Plunger Needle

No marks on needle surface or the edge.

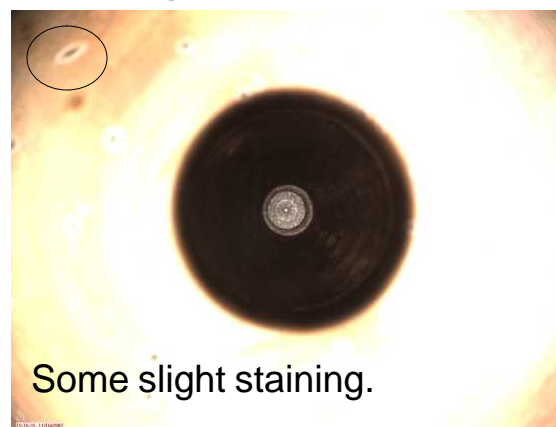
Plunger Needle – Top View

Some slight staining.

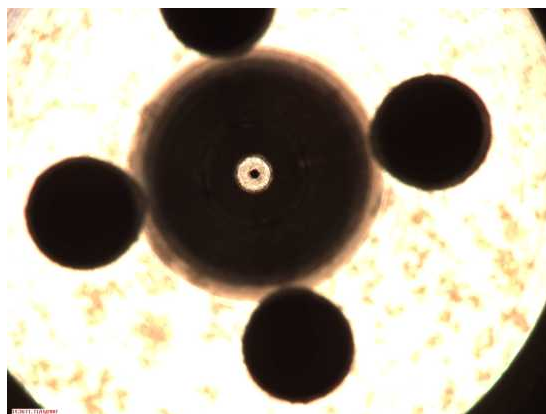
Plunger Orifice
not clogged with
oil sludge or
deposits

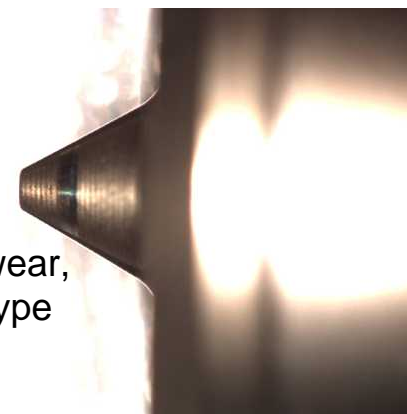
Stage 2 **Plunger Needle** has some wear, but normal for this type of aggressive test.
